Repair and Strengthening of the Reinforced Concrete Lighting Pole using PCC and FRP Systems

Sokołowski Piotr and Kossakowski Paweł Grzegorz*

Department of Strength of Materials, Concrete and Bridge Structures, Faculty of Civil Engineering and Architecture, Kielce University of Technology, Al. Tysiąclecia Państwa Polskiego 25-314 Kielce, Poland

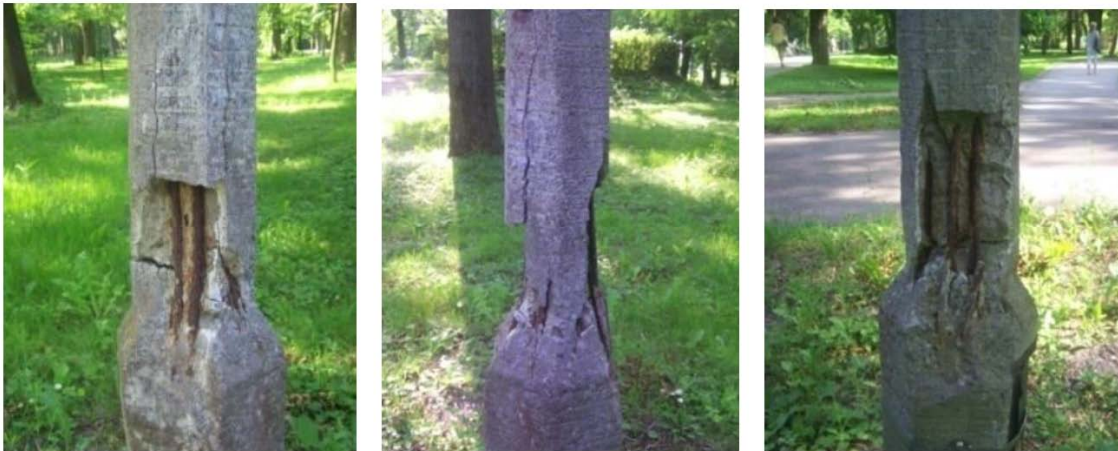
The lighting pole is located in Poland, in Busko-Zdrój in the Spa Park. It was placed in the '90s of the last century. Since that time, no maintenance has been carried out. Inspection revealed deviations from the vertical, cracks, loss of concrete, exposure of reinforcing steel, and corrosion. This damage to the lighting pole is clearly visible in Figure 1.

The main causes of the damage were atmospheric factors (rain, wind, frost) and mainly no maintenance. The reason may also be cracks and longitudinal scratches in concrete, which were not revealed during production. After many years of operation they could be enlarged as a result of atmospheric factors. Nevertheless, the proper maintenance of the lightning post would certainly not lead to such significant damage, which is required in accordance with the Construction Law^[1].

Figure 1: Damage of the lighting pole.

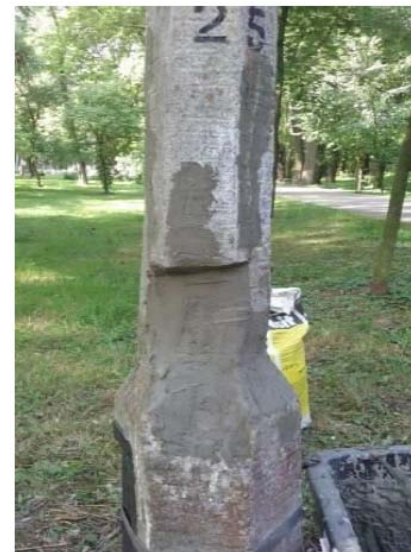
Figure 2: Application of the mortar contact layer Ceresit CD 30.

The first step was to prepare Ceresit CD 30 mortar. This is a contact and corrosion protection layer. For this

as shown in Figure 2. Next, at 60 minutes after the initial drying of the mortar, the application of Ceresit CD26 coarse-grained mortar for filling losses from 30 to 100 mm began. The contents of the packaging were mixed with water, using approx. 3-3.2 liters of water per 25 kg of the mortar. The substrate was wetted with water before applying the layers. Then, with a trowel, layers of mortar were applied to the previously laid contact layer, forming the appropriate shape with the help of a trowel (Figure 3).

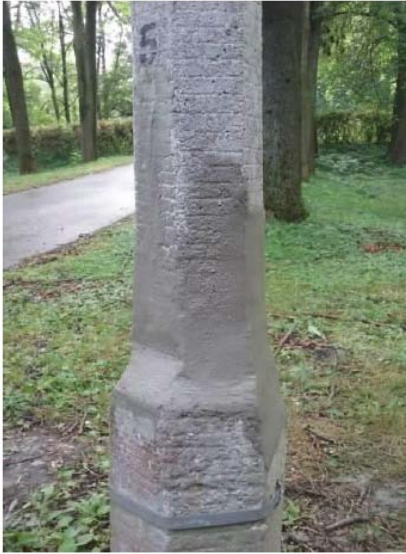
Figure 3: Application of finishing layer with mortar Ceresit CD 26.

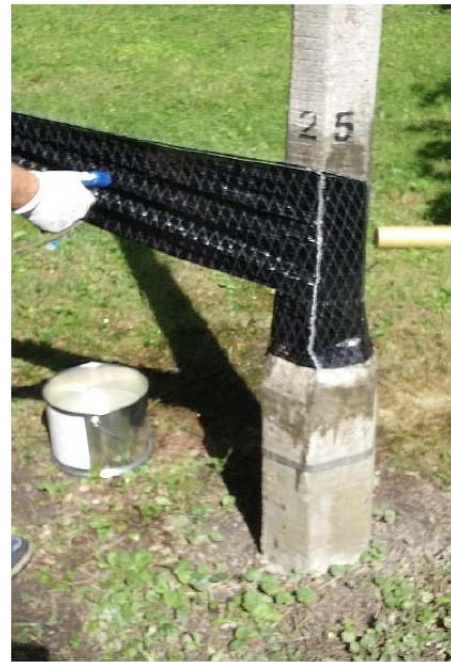
Figure 4: Carbon sheet application.

Work began 48 hours after the last mortar application. First, excess mortar and dust were removed with a putty knife and brush. Then the resin glue was ground S & P Resin 55 consisting of epoxy resin and hardener as directed by mixing both components using a slow-speed drill with a mixer at 200 rpm for 5 minutes until a uniform white color is obtained. Then two thin layers of adhesive were applied to the surface of the pole. The next step was the application of a carbon fiber mat. The sheet was properly tensioned (Figure 4) to prevent the formation of air bubbles. Finally, the mat was covered with 2 layers of resin glue to obtain the final effect, which is shown in Figure 5.

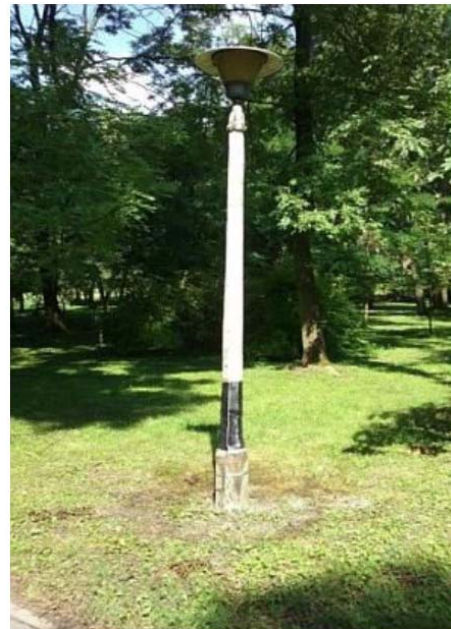
Figure 5: The final effect of the lightning pole repair.
